HgCdTe Detector Reliability Study for the GOES Program

**David G. Seiler
George G. Harman
Jeremiah R. Lowney
Santos Mayo
Walter S. Liggett, Jr.**

**U.S. DEPARTMENT OF COMMERCE
National Institute of Standards
and Technology
Gaithersburg, MD 20899**

September 1991

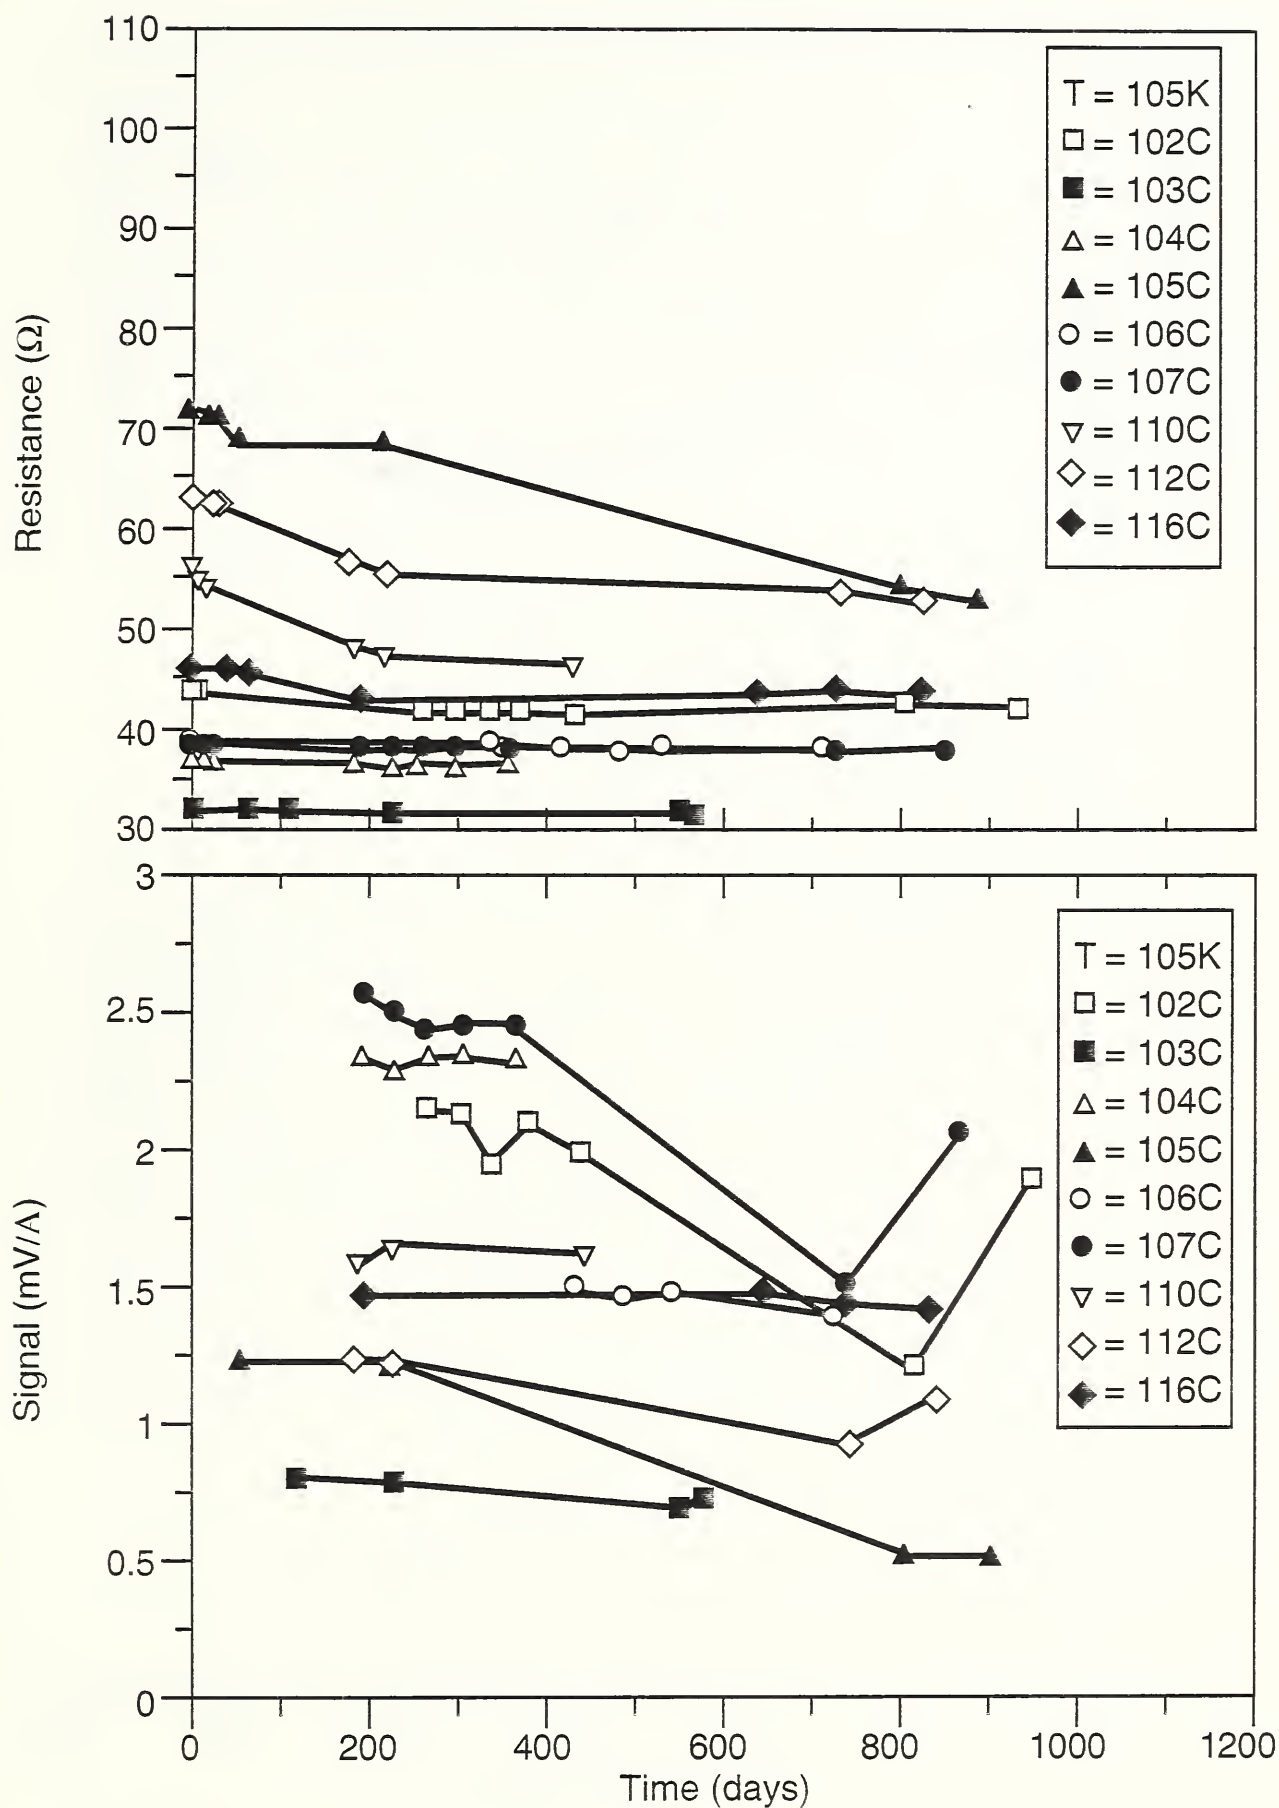
Figure D.5 Resistance (top) and signal (bottom) of element C of the 11- μm detectors with aplanat lens as a function of time.

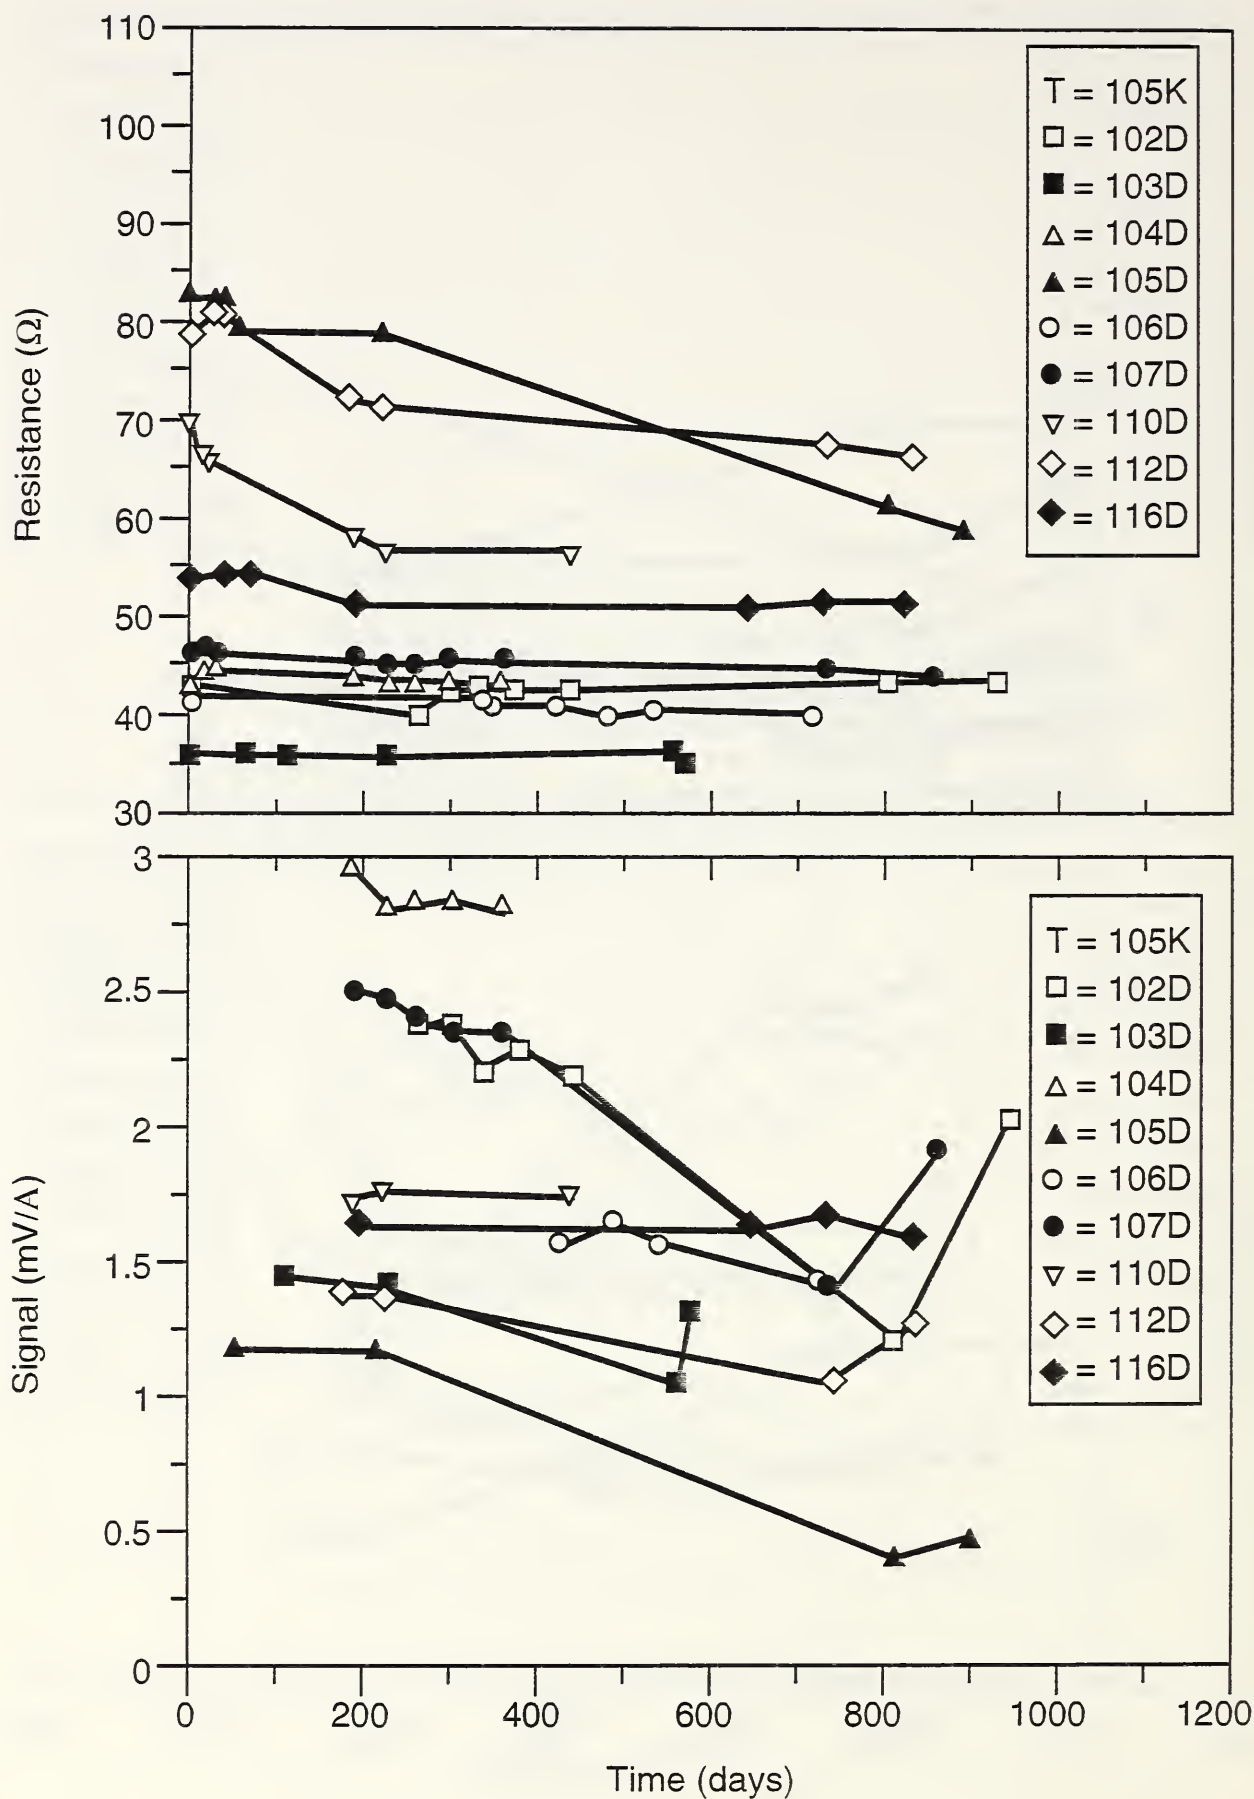
Figure D.6 Resistance (top) and signal (bottom) of element D of the 11- μ m detectors with aplanat lens as a function of time.

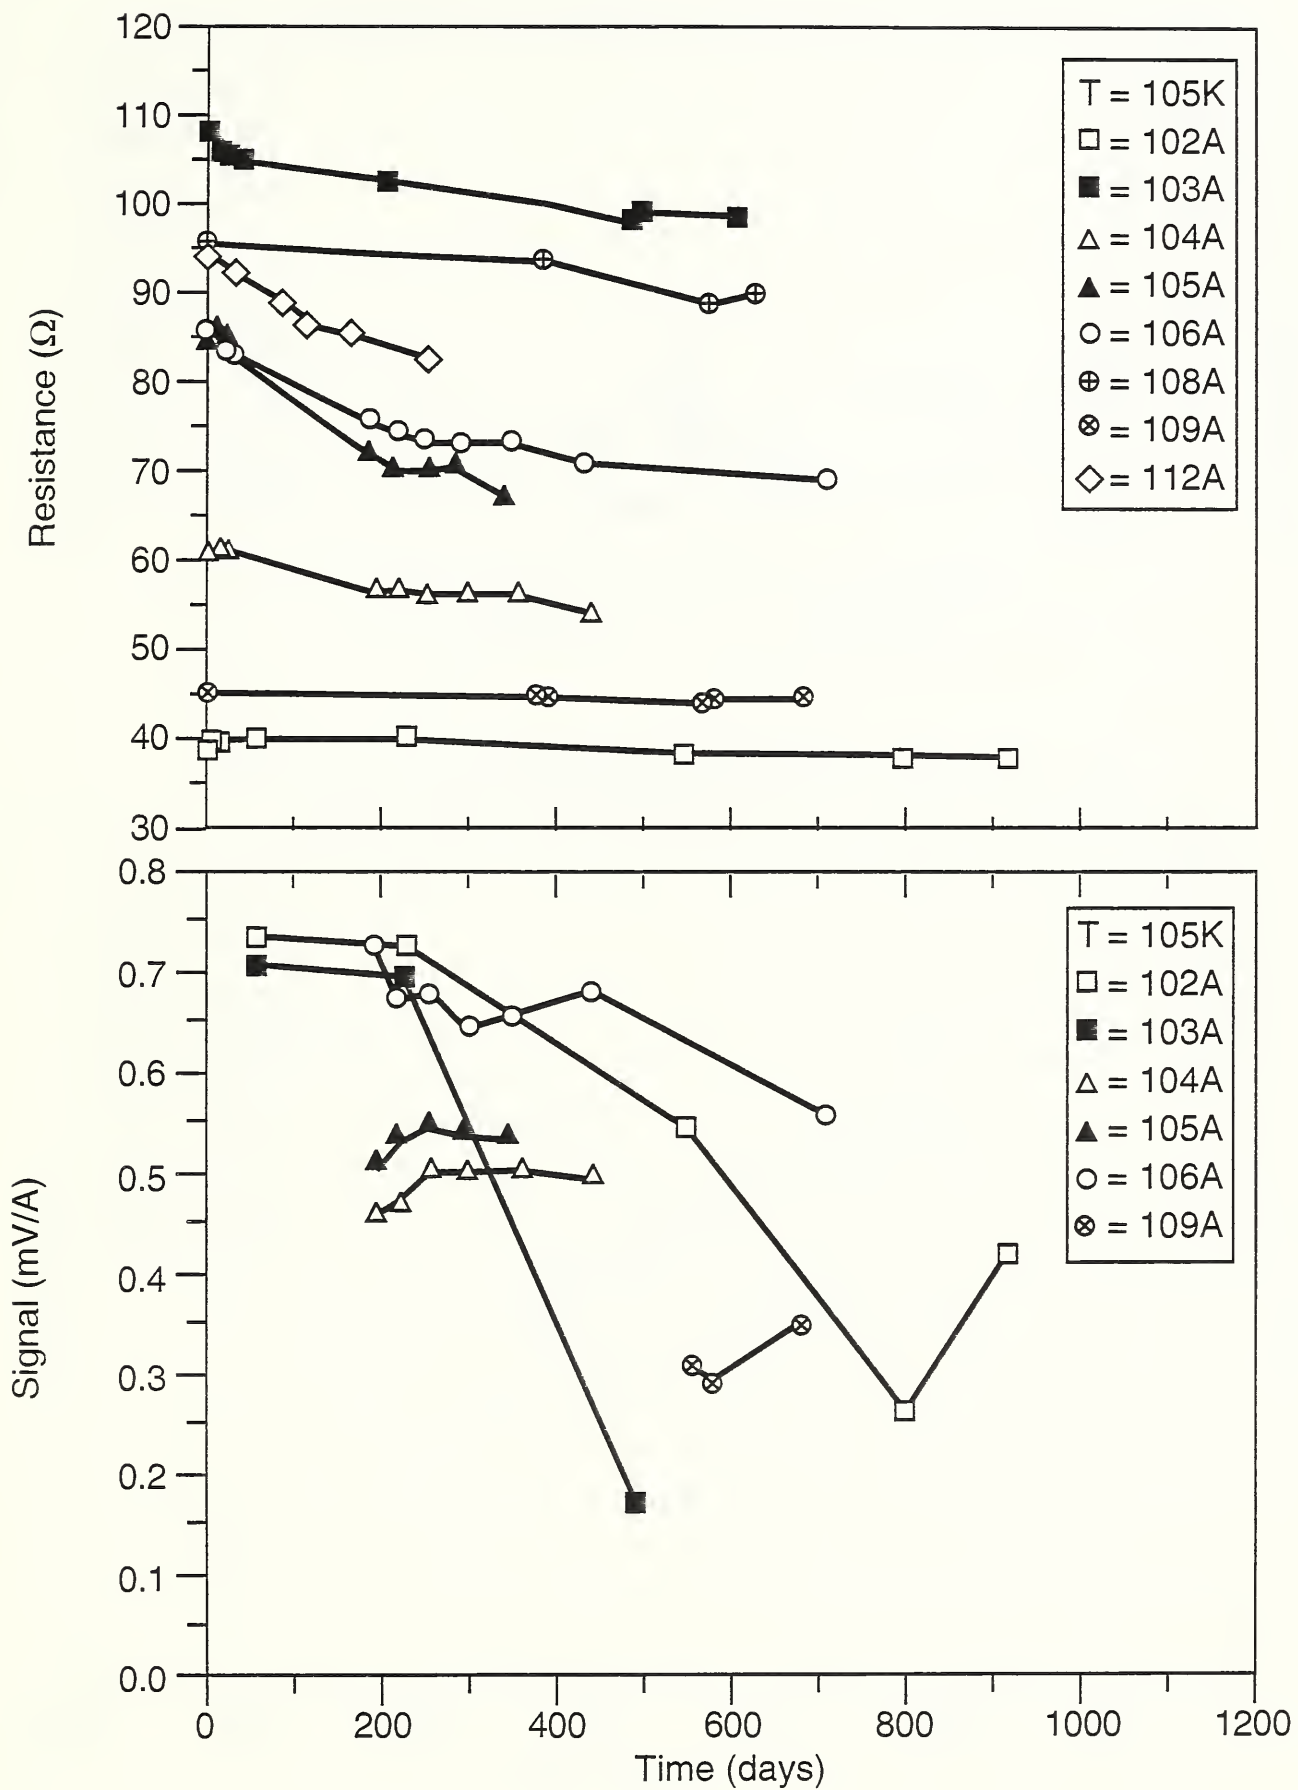
Figure D.7 Resistance (top) and signal (bottom) of element A of the 12- μ m detectors with aplanat lens as a function of time.

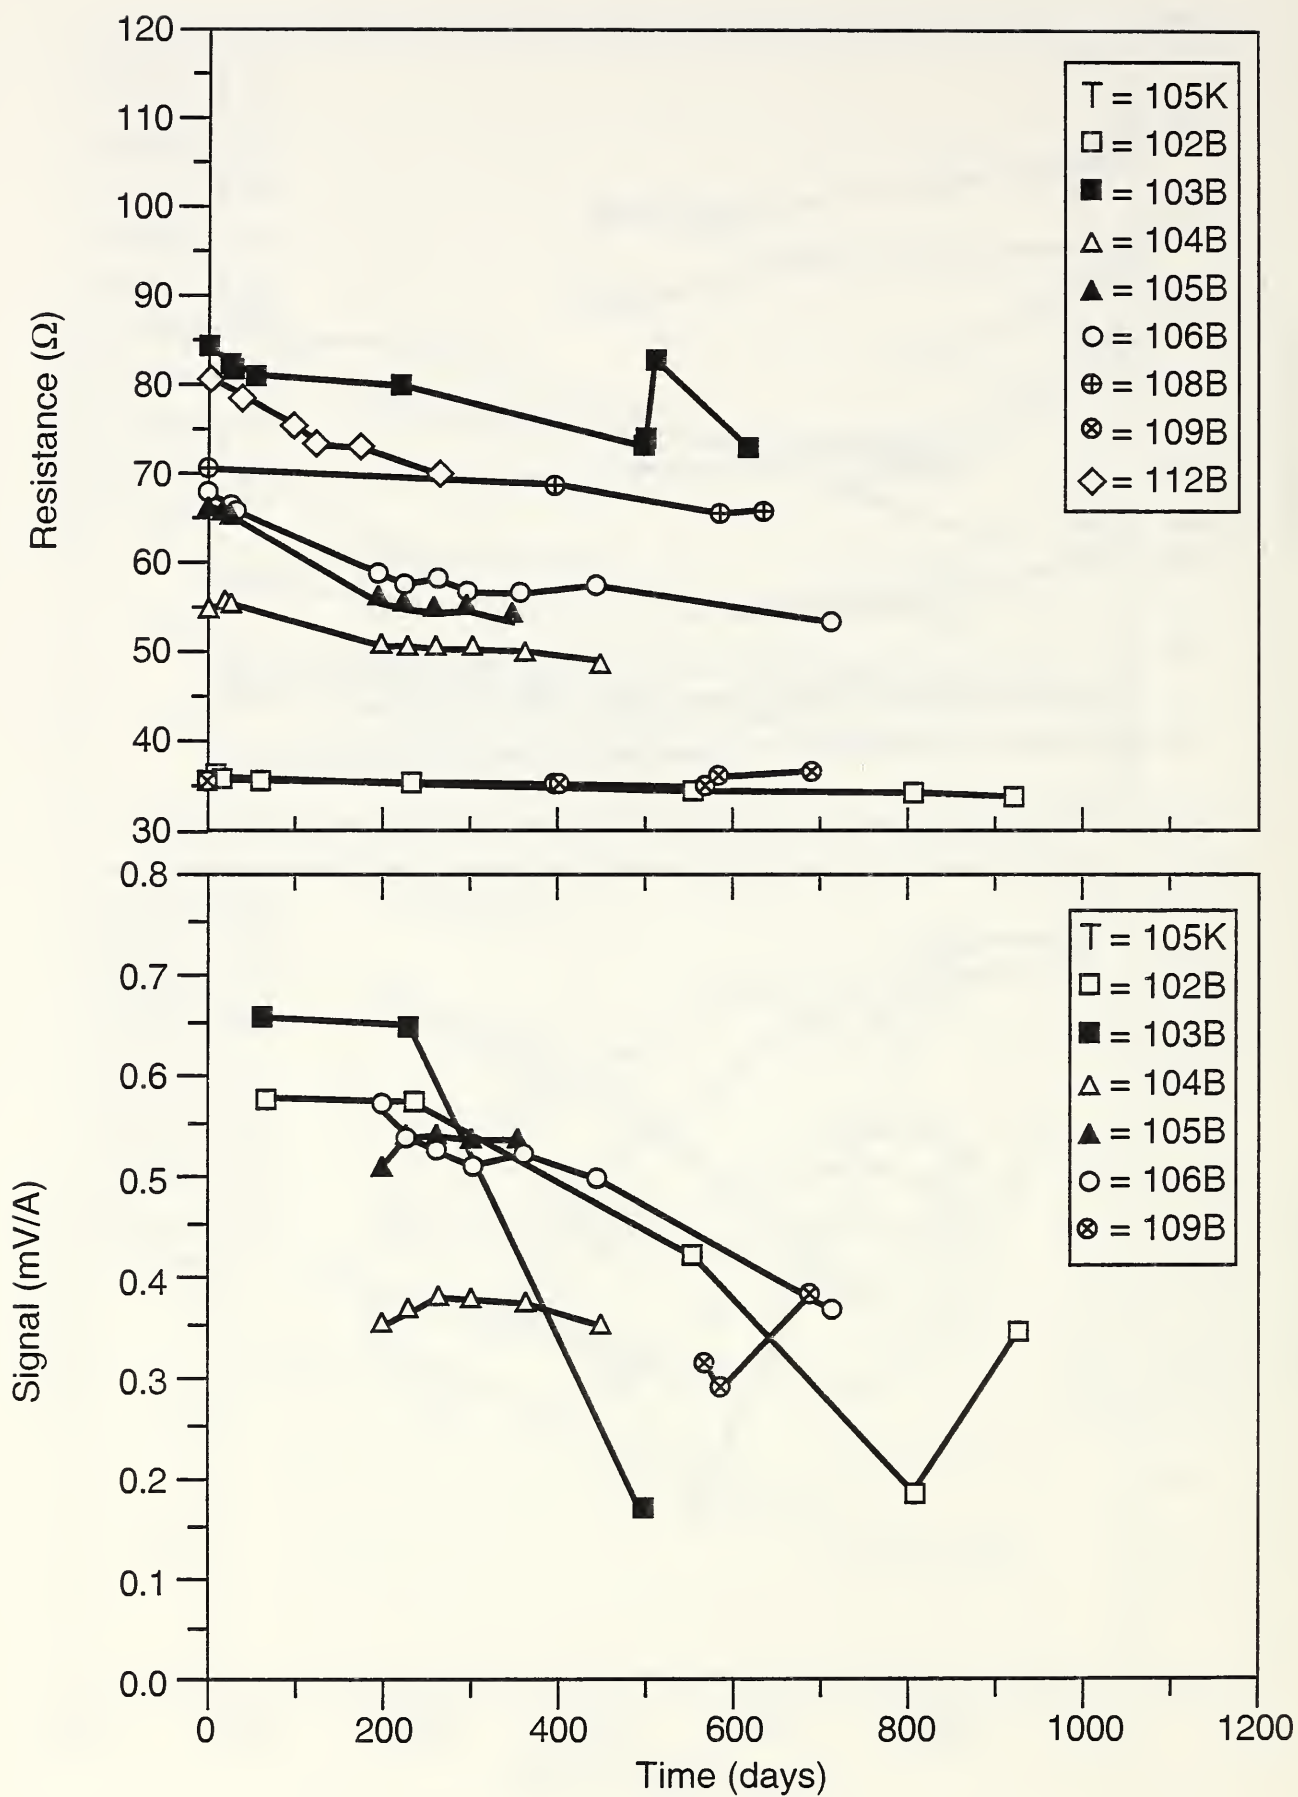
Figure D.8 Resistance (top) and signal (bottom) of element B of the 12- μ m detectors with aplanat lens as a function of time.

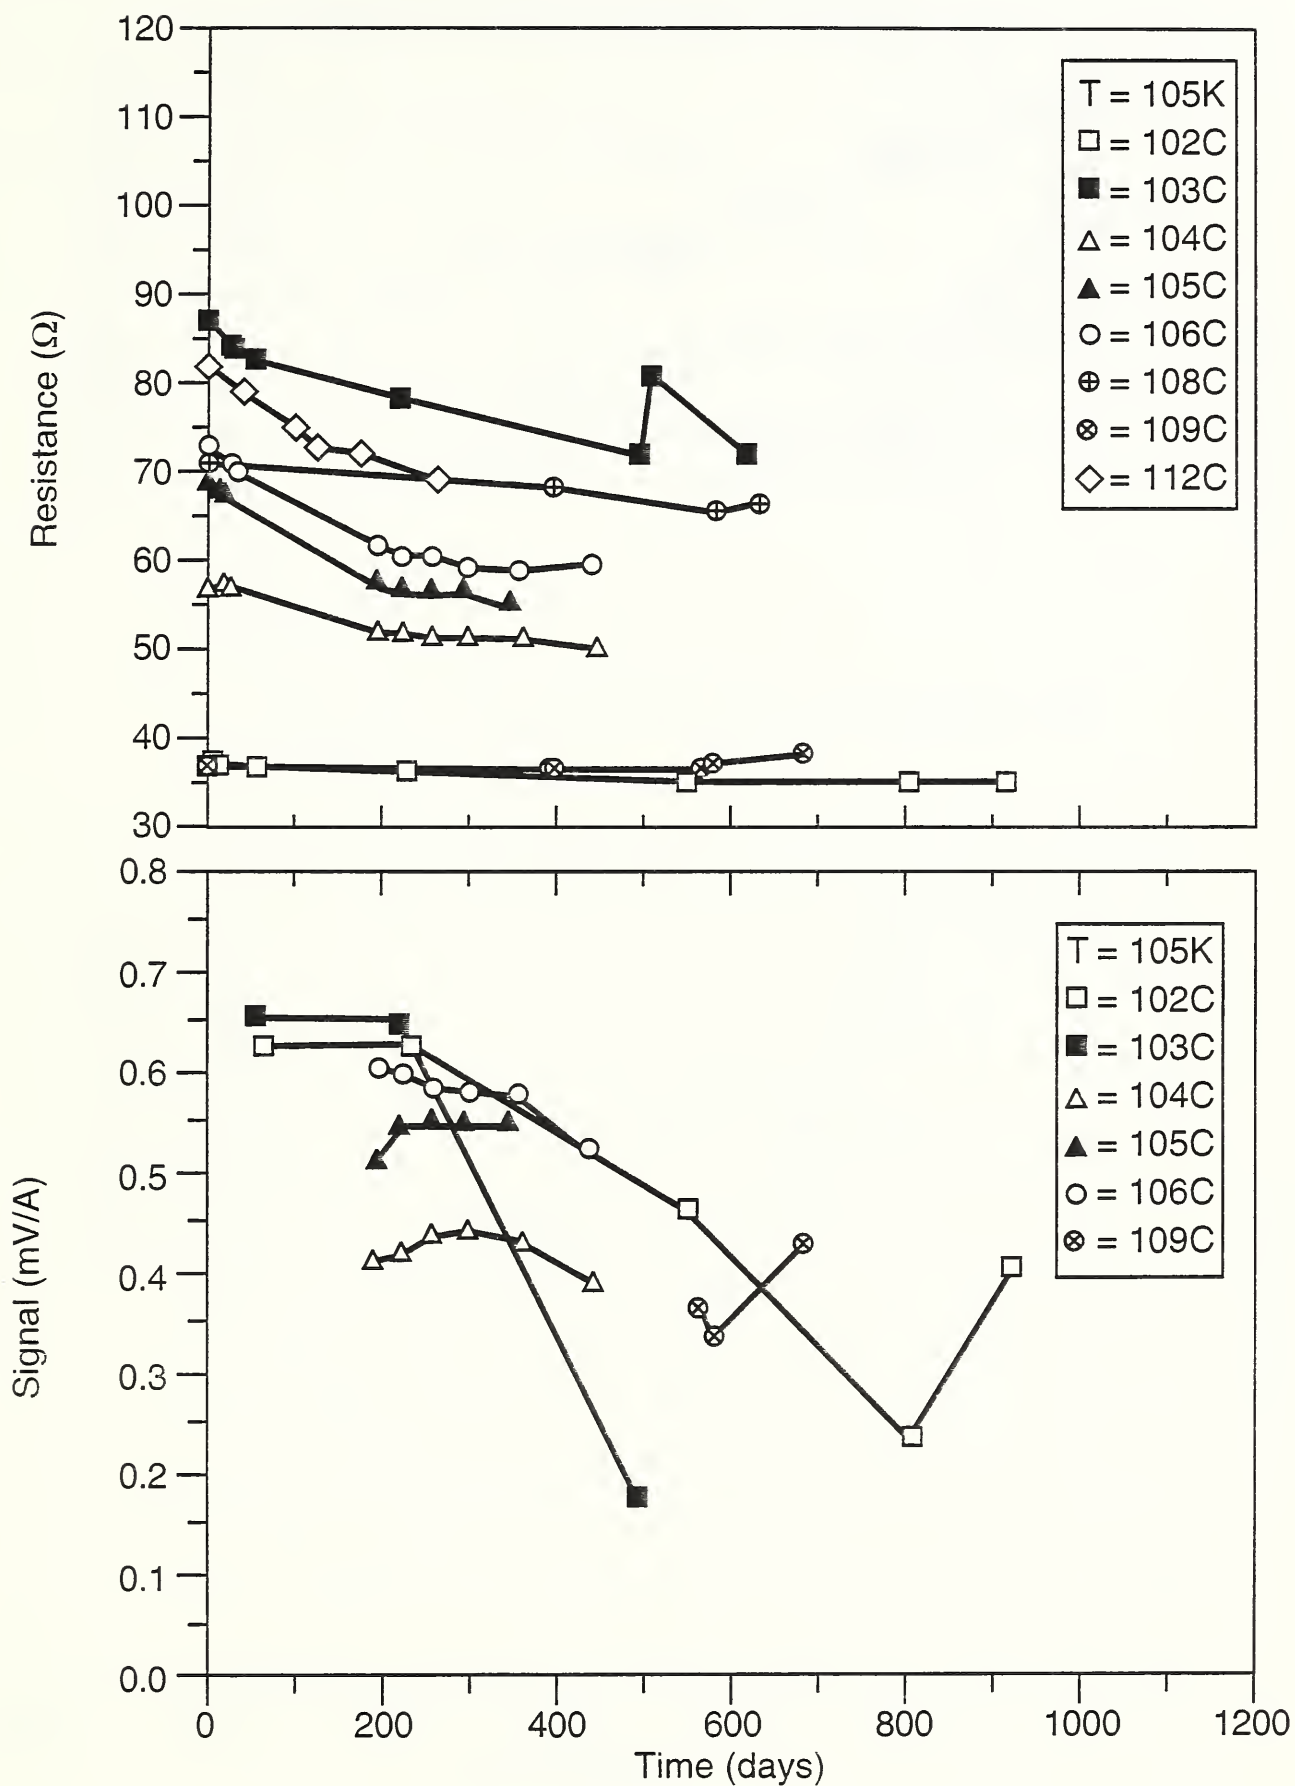
Figure D.9 Resistance (top) and signal (bottom) of element C of the 12- μ m detectors with aplanat lens as a function of time.

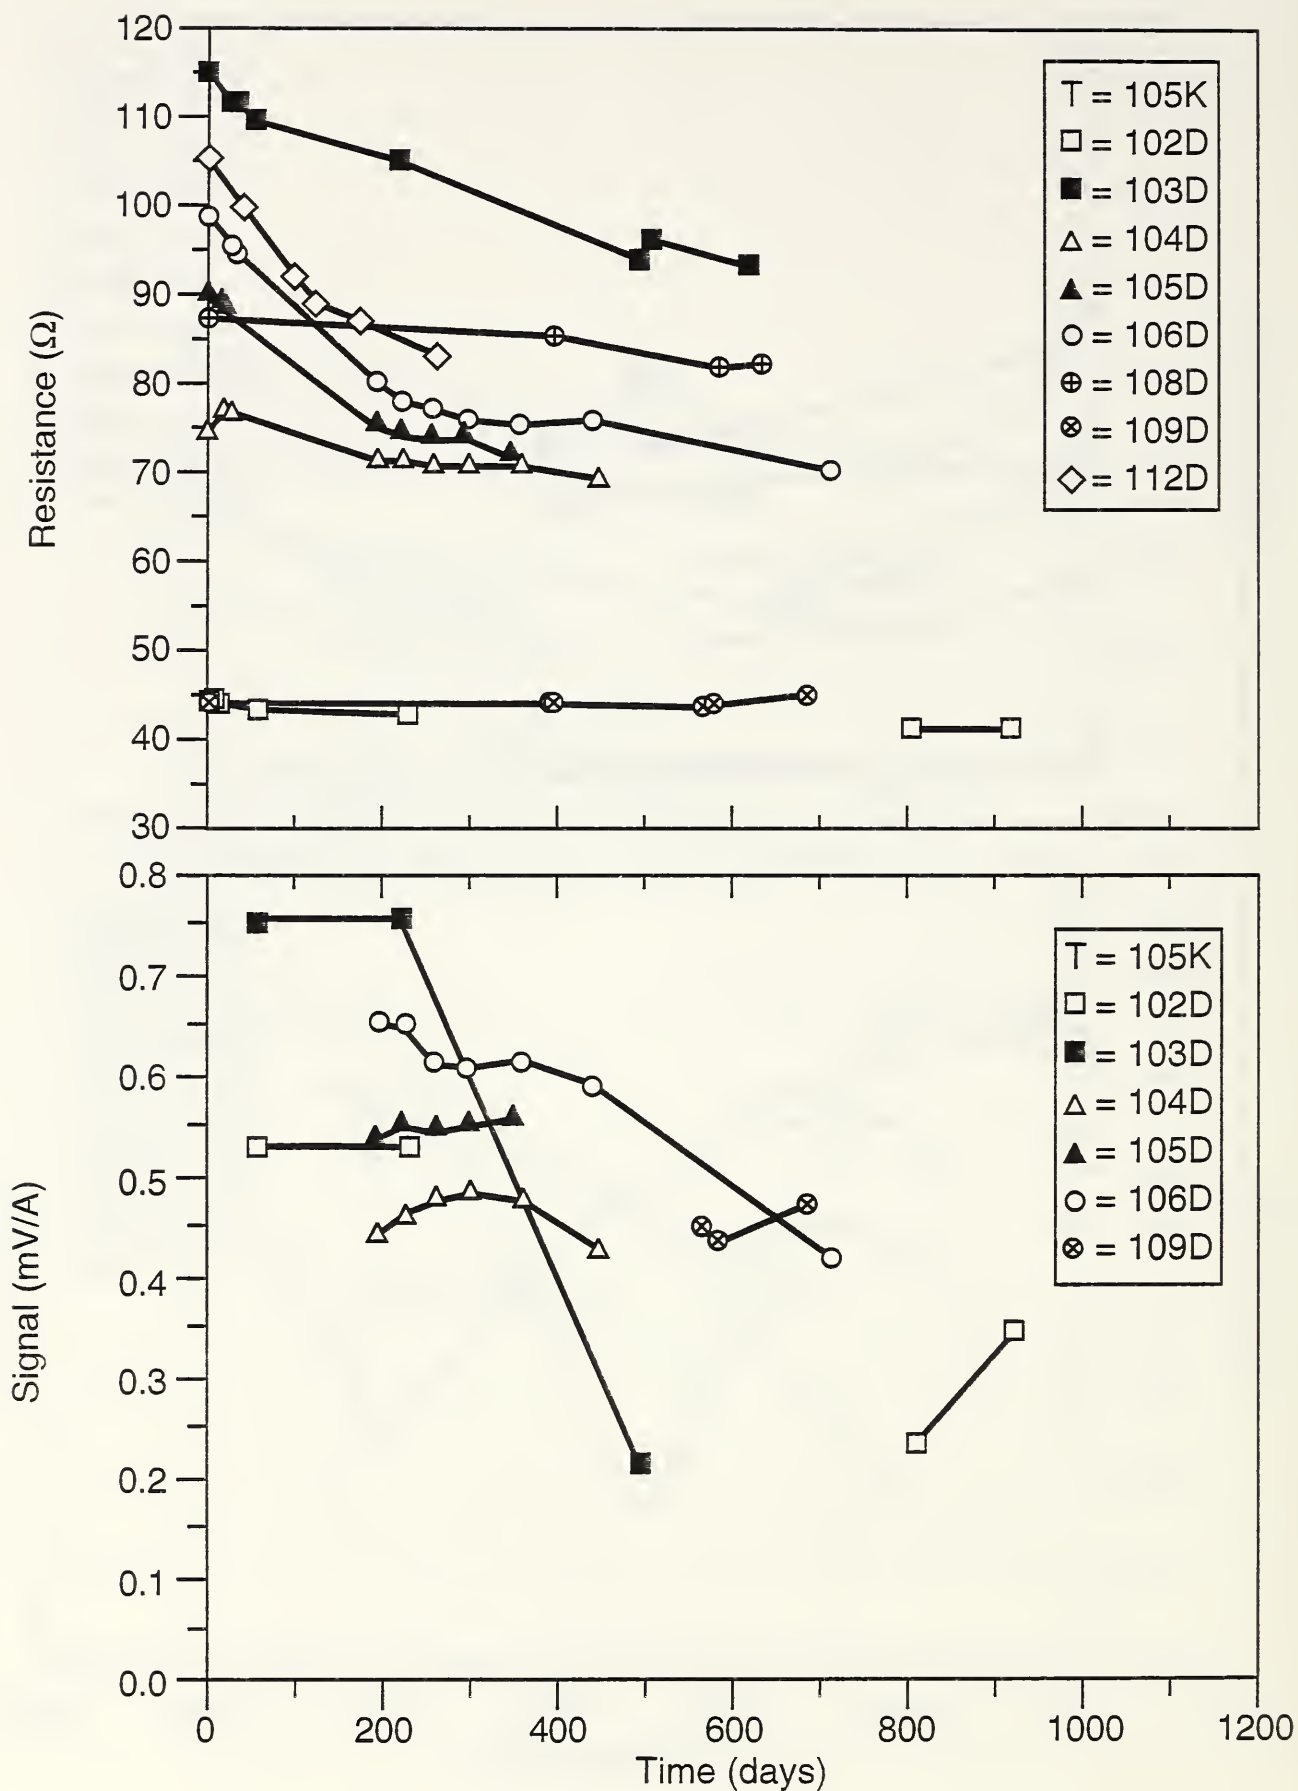
Figure D.10 Resistance (top) and signal (bottom) of element D of the 12- μ m detectors with aplanat lens as a function of time.

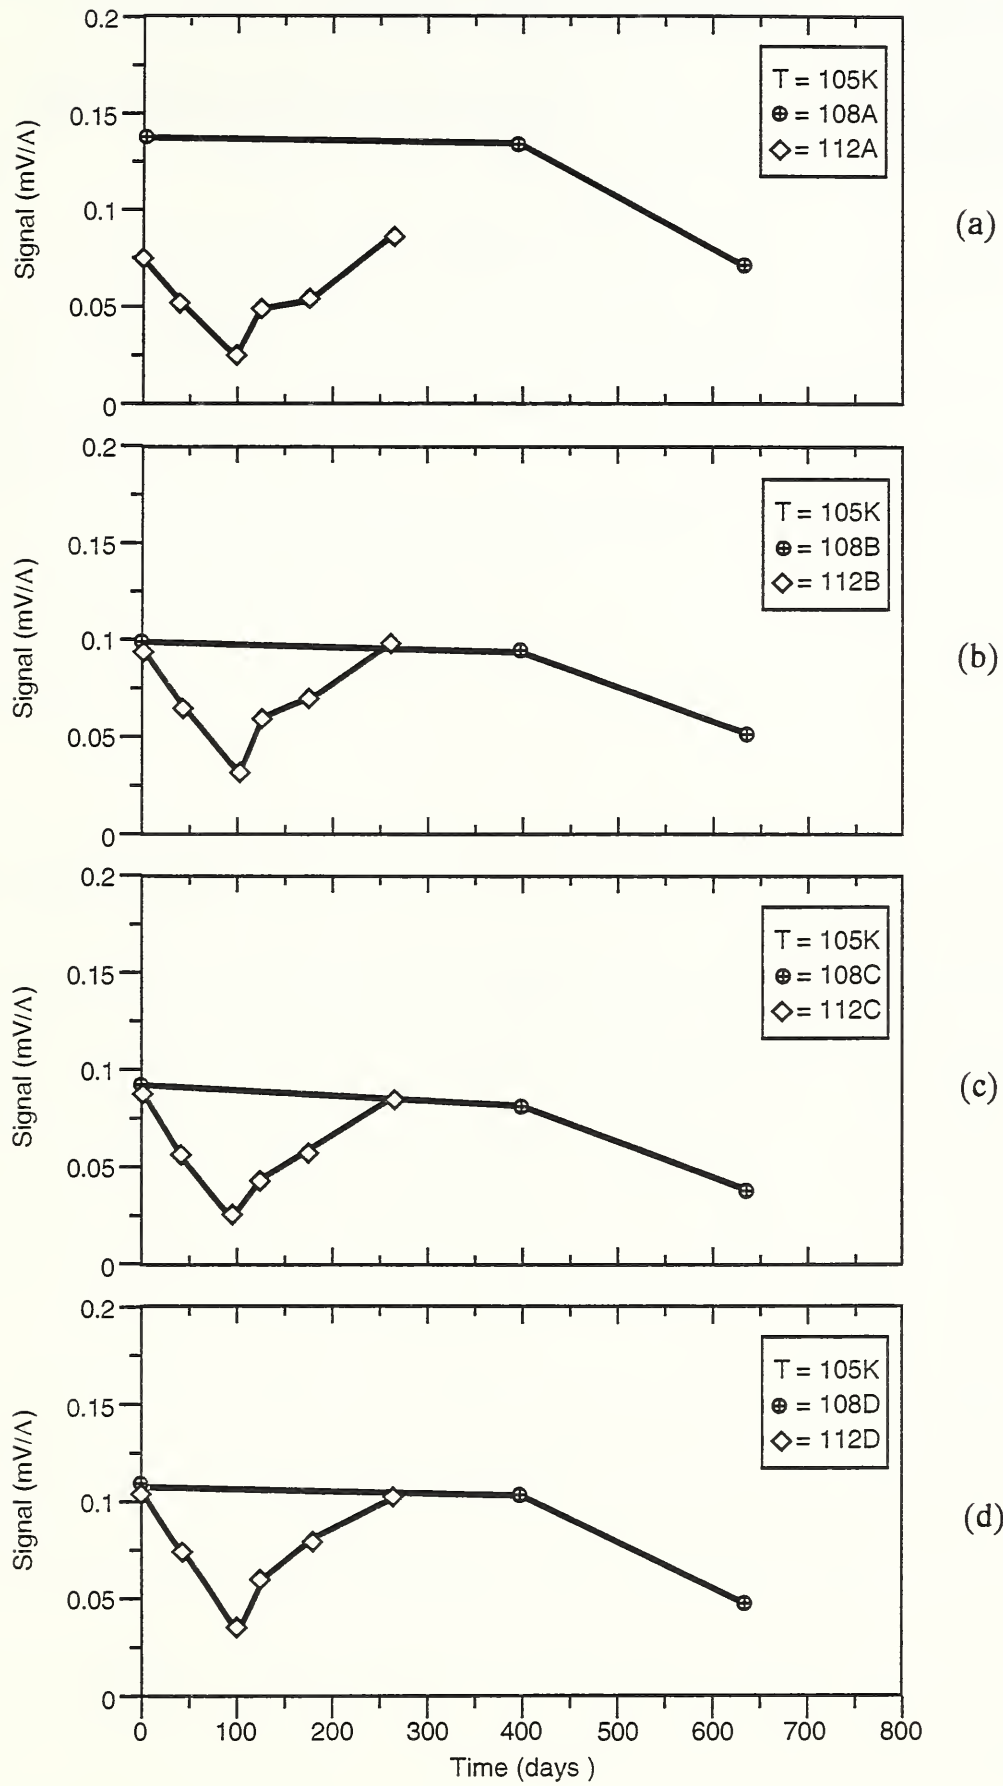
Figure D.11 Signals of elements of the 12-μm detectors without aplanat lens as a function of time. (a) Element A, (b) Element B, (c) Element C, and (d) Element D.
